Manhole Inspection Summary

Manhole # S31M__017MH

Insp Date: **3/16/09 12:47 PM**

Location Address: **CAMDEN YARDS, EUTAW ST,
WAREHOUSE F**

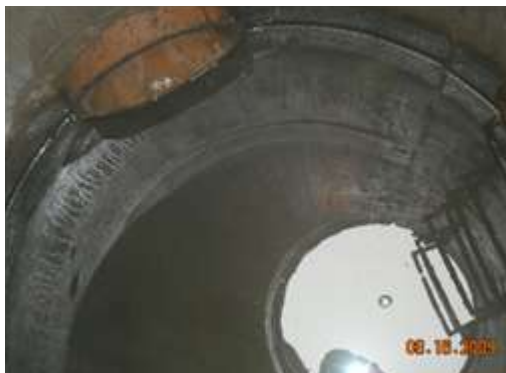
MISC.

Comments **NO CHANNEL OR BENCH IN STRUCTURE; LOCATED NEXT TO VETERANS
MEMORIAL; USED 16LB MAUL AND SPRAY LUBRICANT TO FORCE OPEN COVER;
STEAM IN LINE.**

NO BENCH OR CHANNEL; IT APPEARS THAT IT WAS NEVER CONSTRUCTED

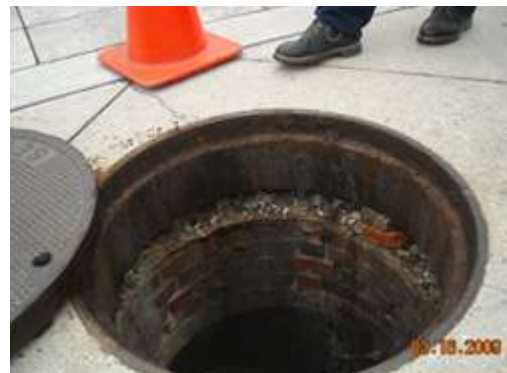
MISC.

☐ Prev. Rehab Weather: **Dry** Subject To Ponding: **Sheeting**

INFLOW EVIDENCE FROM SHEETING

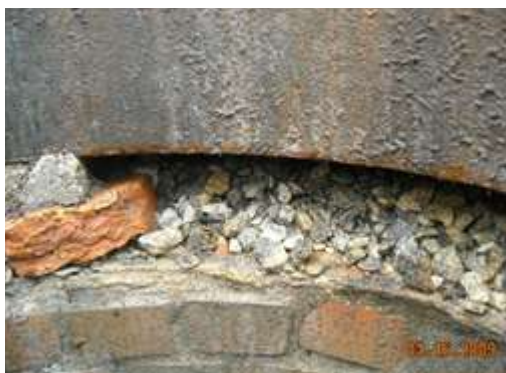
Defect 2

Condition: ☐ Sound ☒ **Cracked** ☐ Root Intrusion ☒ **Loose Brick** ☒ **Deteriorated**

Infiltration: ☒ None ☒ **Joint** ☐ Cracks ☐ Mortar ☐ Roots ☐ Wall

Cracks, Loose Bricks and Deteriorating Chimney. Chimney Infiltration

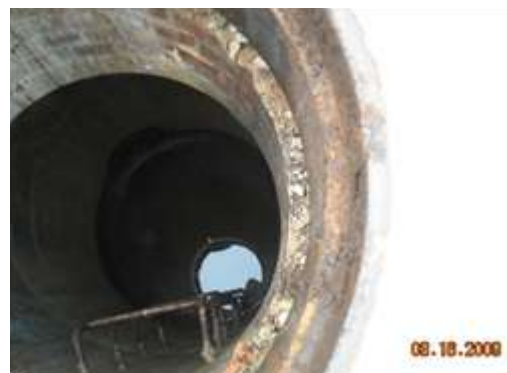
Defect 1

Frame Offset: **1** (in.) Condition: ☒ Sound ☐ Cracked ☐ Leaks

FRAME OFFSET
